## 4.0 DESCRIPTION OF THE DECEMBER 14, 2005 INCIDENT

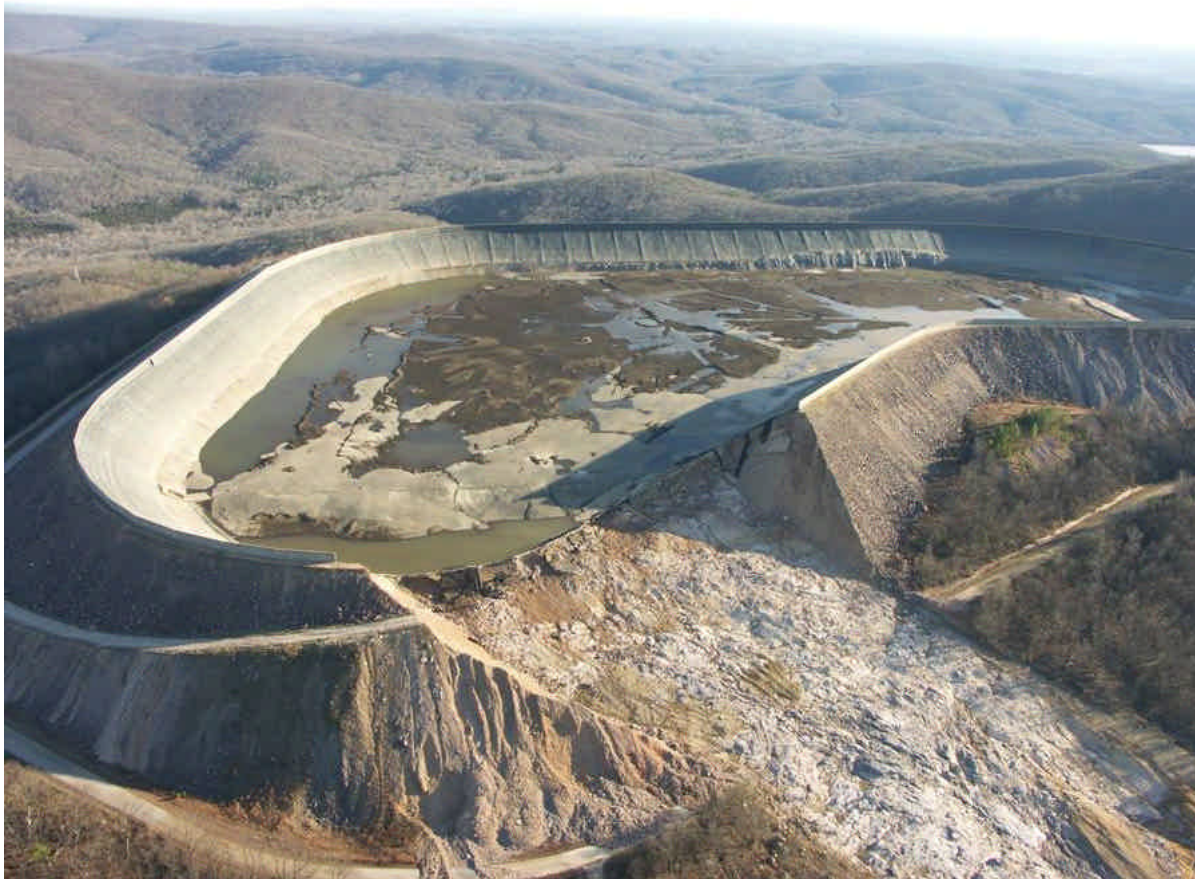
**FIGURE 4-1**

During the early morning hours, around 5:00 AM, the northwest corner of the Dike around the Upper Reservoir breached over a width of about 700 feet, causing an uncontrolled, rapid release of water down the west slope of Profitt Mountain and into the East Fork of the Black River. An overall aerial view of the flow path is shown on *Figure 2-1*. The following series Figures (*Figures 4-1 to 4-6*) provide a photographic description of the incident.

**OVERALL VIEW OF THE BREACHED DIKE**

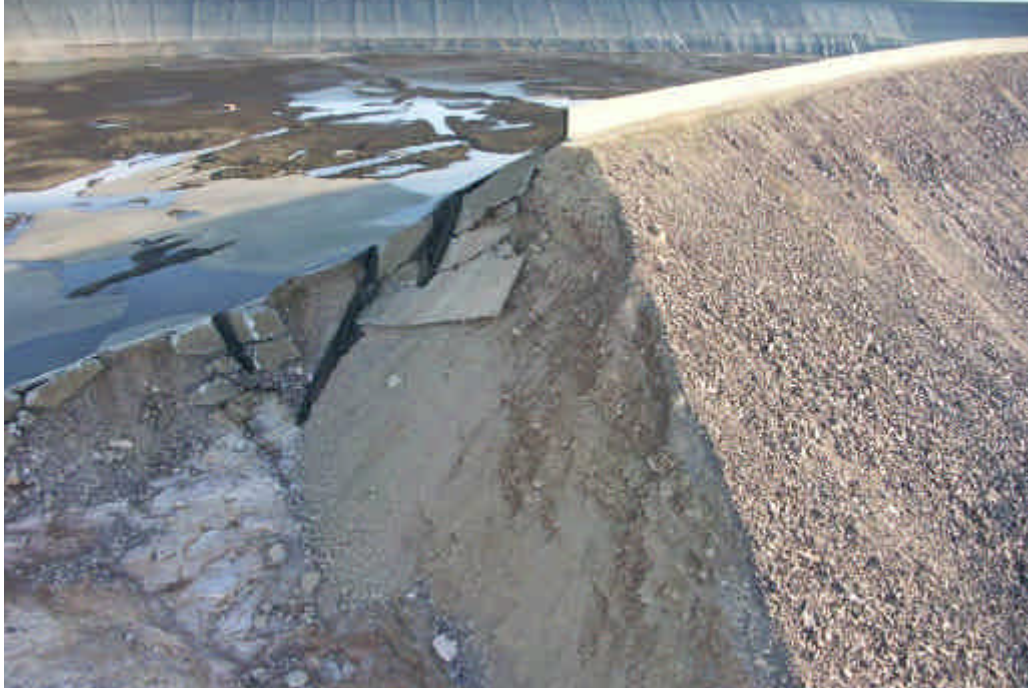
**FIGURE 4-2**  
**CLOSE UP VIEW OF WEST SIDE OF BREACH AREA**

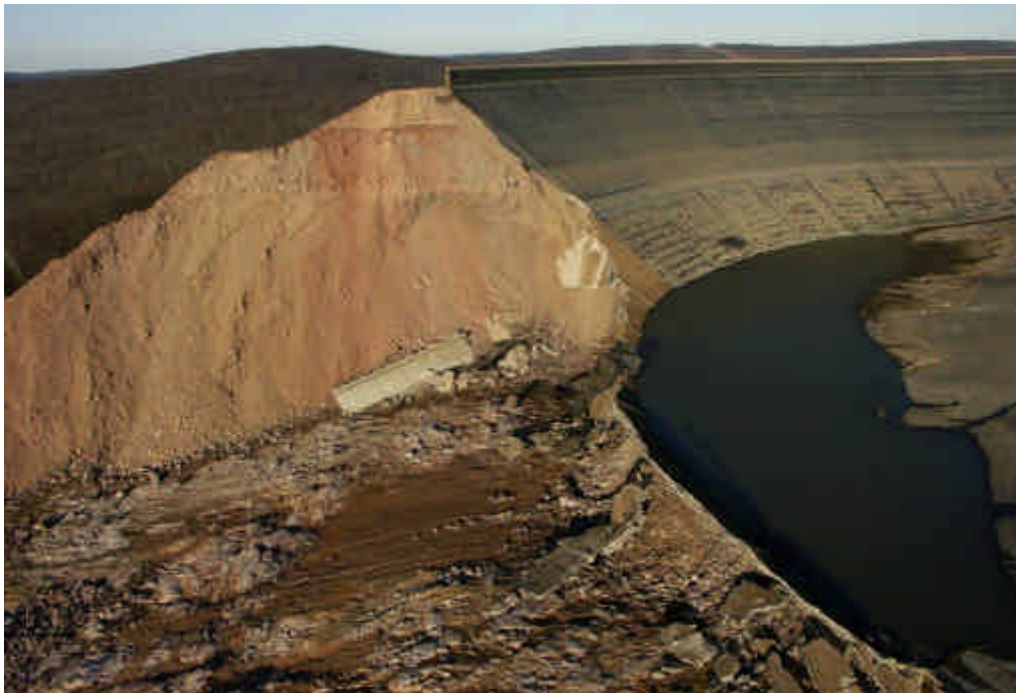
**FIGURE 4-3**  
**CLOSE UP VIEW OF EAST SIDE OF BREACH AREA**

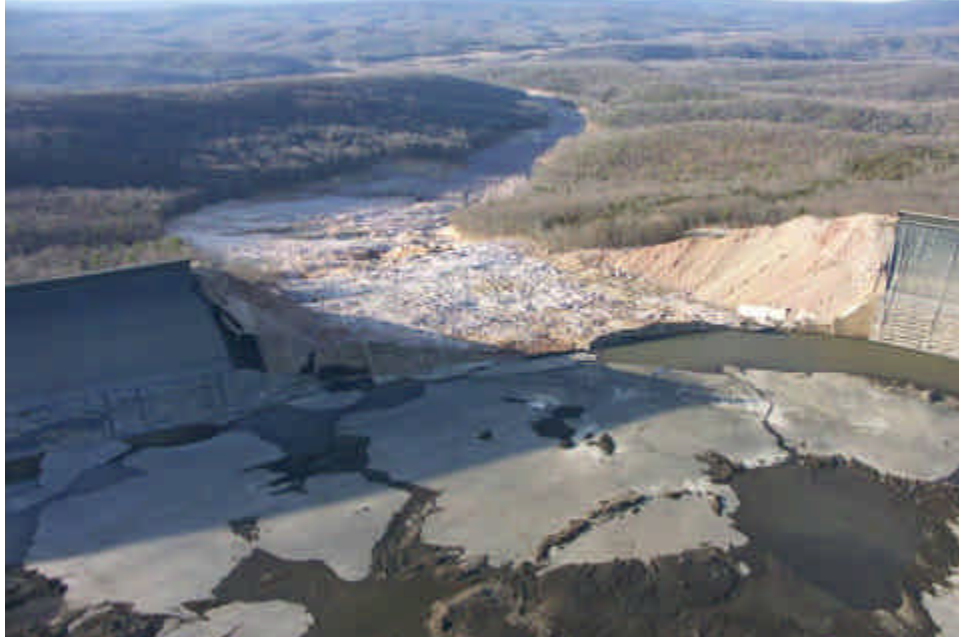
**FIGURE 4-4**

**VIEW FROM INSIDE UPPER RESERVOIR TOWARDS FLOW CHANNEL**

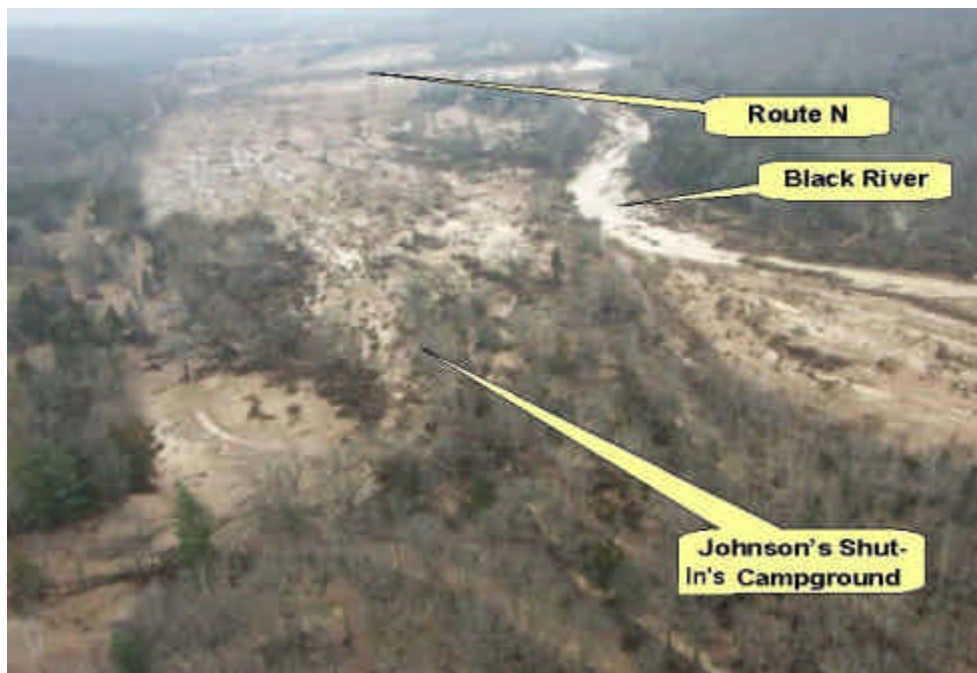
**FIGURE 4-5**

**VIEW LOOKING NORTH AT FLOW CHANNEL**

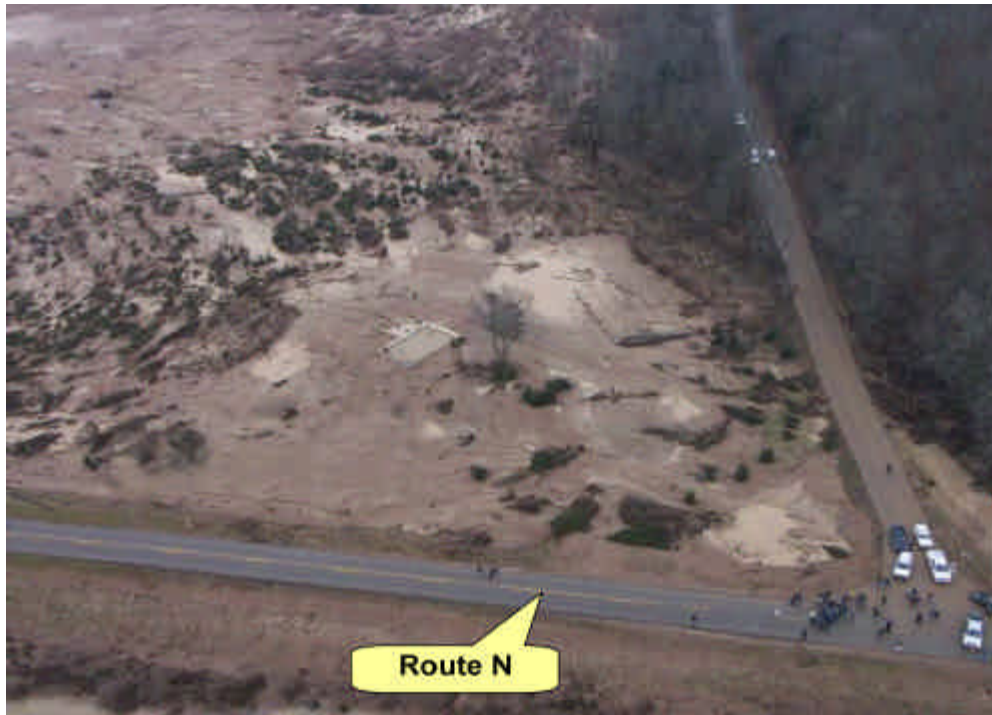
**FIGURE 4-6**

**VIEW OF FLOW CHANNEL AND ROUTE N**
